## CIVIL AERONAUTICS BOARD

## ACCIDENT INVESTIGATION REPORT

UNITED AIR LINES, INC., NEAR OAKLAND, CALIFORNIA, AUGUST 24, 1951

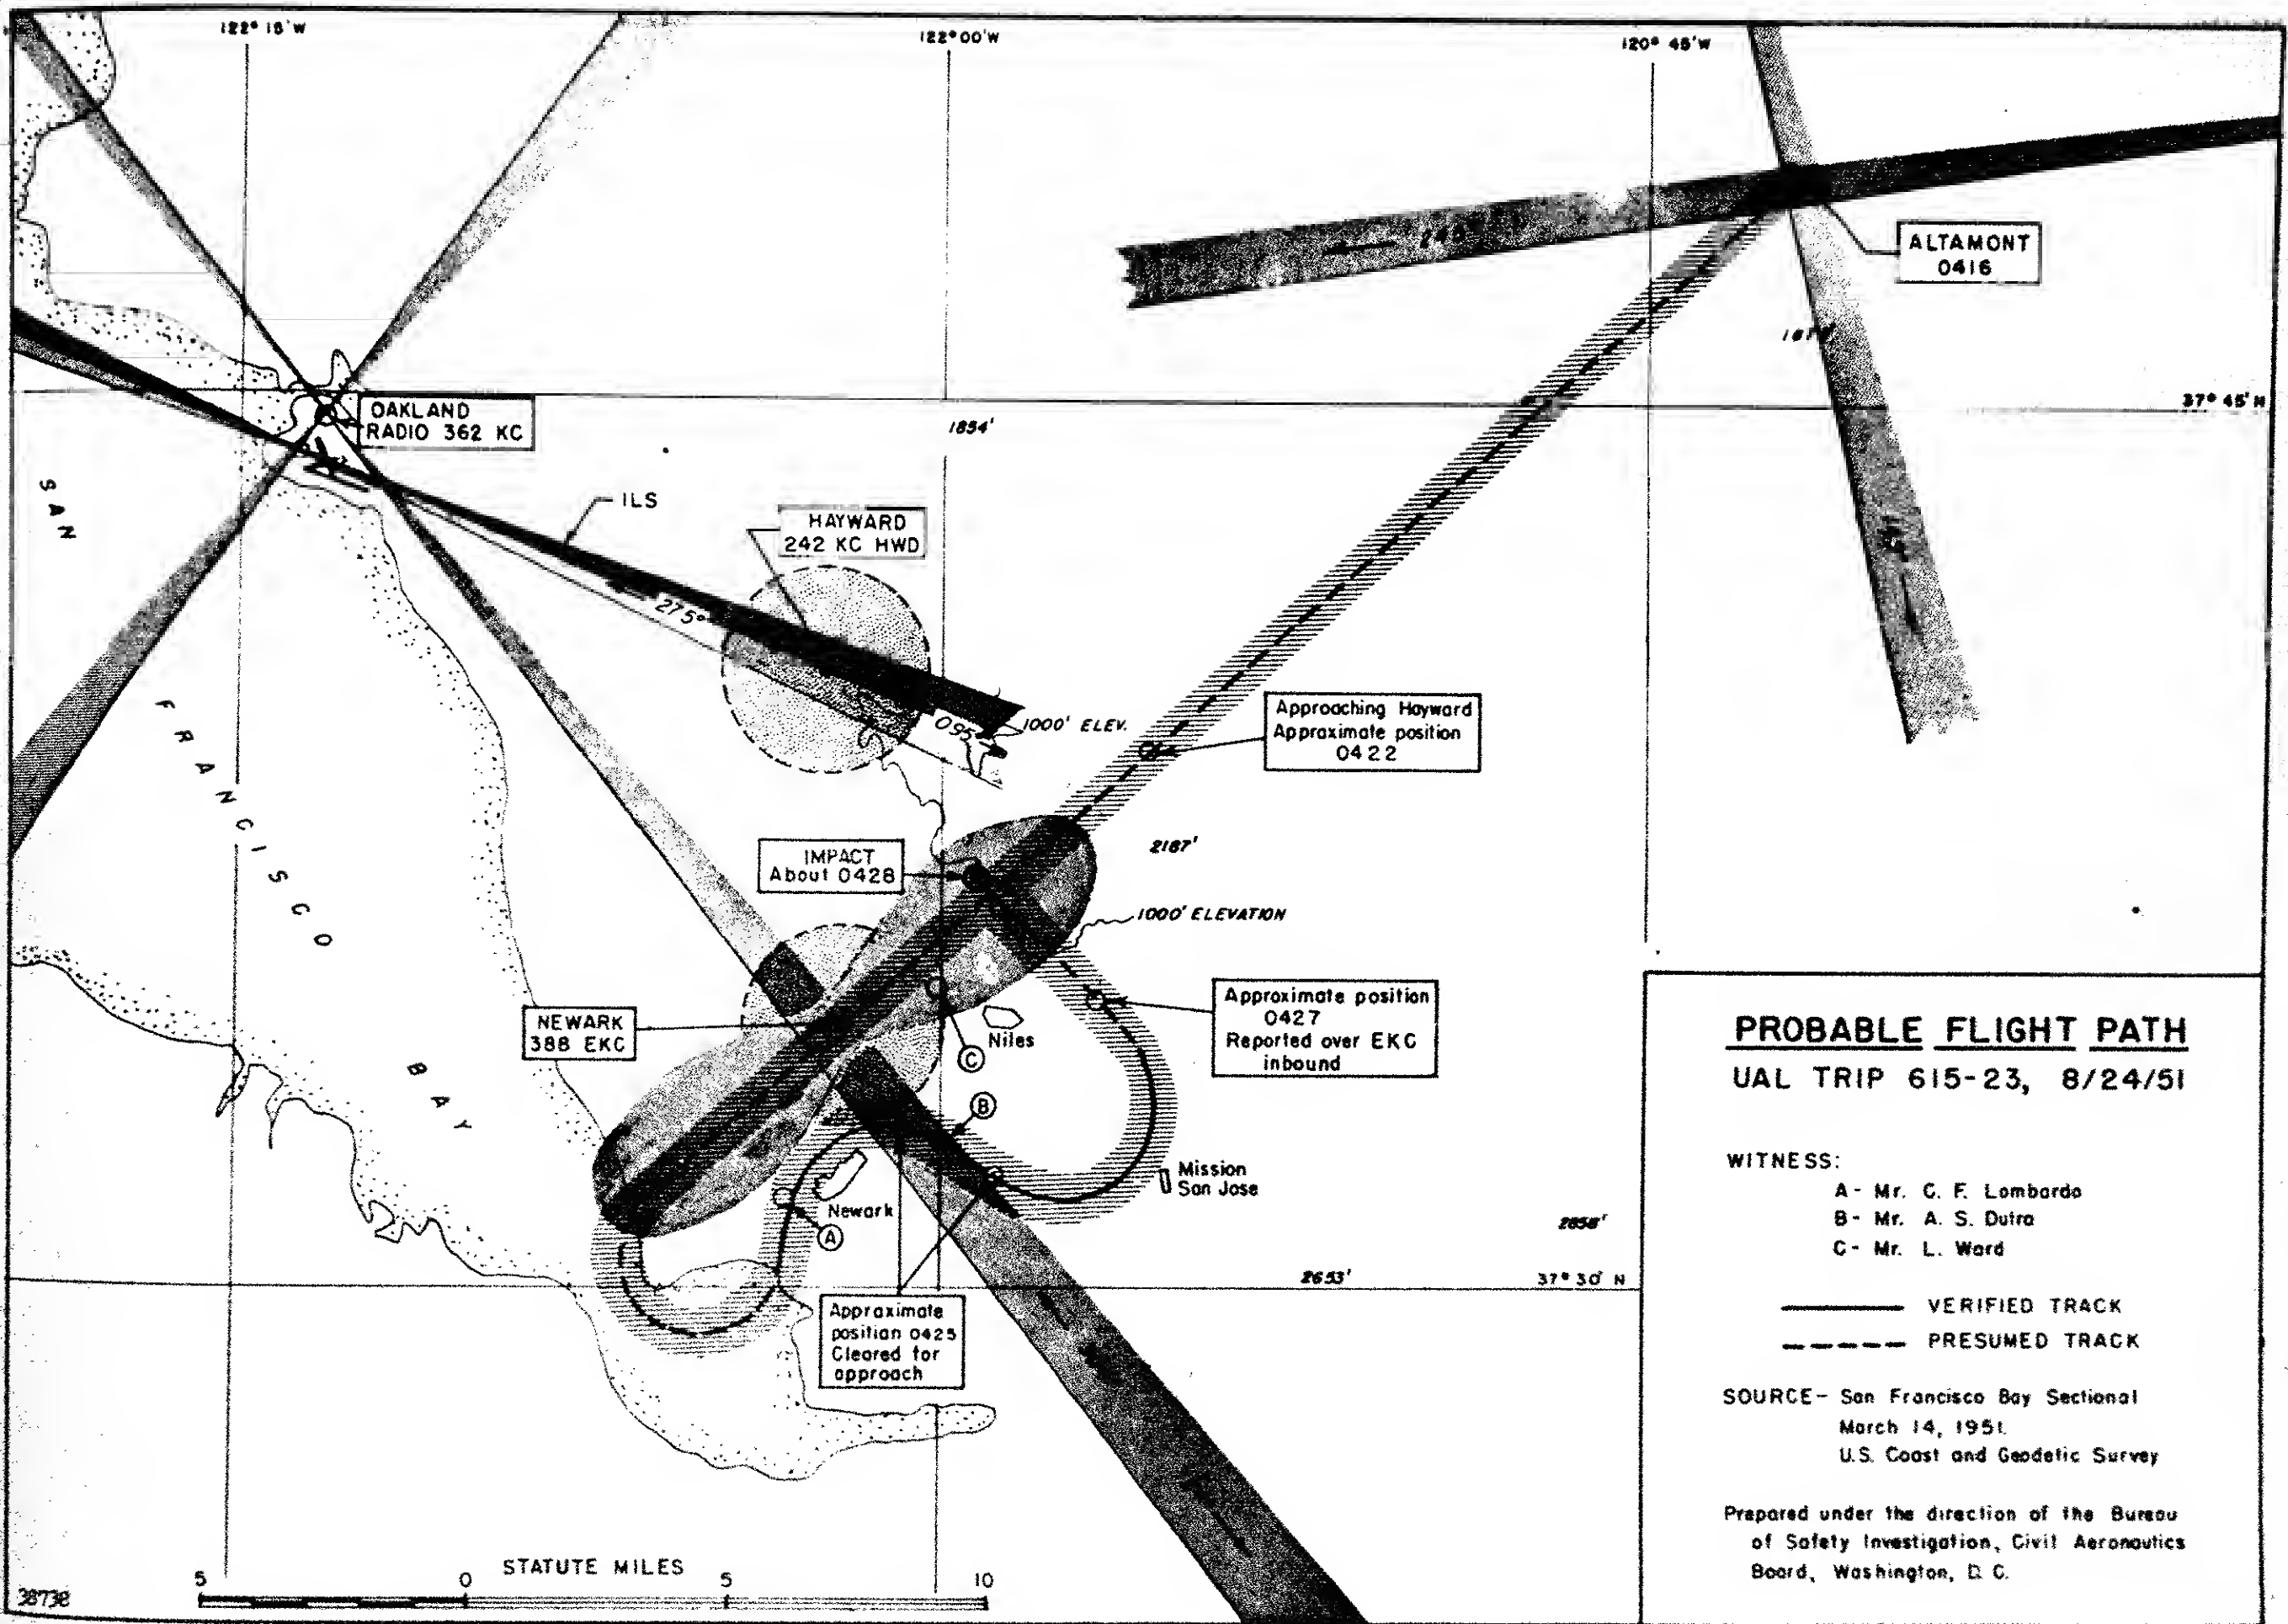
**PROBABLE FLIGHT PATH**  
**UAL TRIP 615-23, 8/24/51**

It should be noted that all witnesses stated the aircraft was flying at low altitude in the Newark area and reconstruction of the flight path indicated the altitude was in the neighborhood of 1,500 to 2,000 feet prior to the final, straight descent. It has been pointed out that the flight was still on an IFR flight plan at the time it crashed, and the minimum prescribed altitude prior to leaving Newark is 3,500 feet. Flight 615 was neither at least 500 feet above the top of the stratus layer nor adhering to the minimum altitude of 3,500 feet as it maneuvered awaiting clearance to Oakland. Witnesses reported that it was below, or just skirting, the lower side of the clouds.

A radio transmission was made by the flight one minute before the accident, advising that it was leaving Newark inbound. Final letdown to 500 feet is permissible past that point, and according to the last witness, the aircraft was descending during the time it was in his view. Plotting back one minute from the crash site, using the probable speed of the aircraft it is noted that the flight would have been slightly to the east of the town of Niles at the time the transmission was made. Niles could readily be confused with Newark under conditions of restricted visibility such as obtained at the time. The main section of Newark lies slightly to the left of the southeast course of the Oakland radio range, and occupies the same relative position with the southeast course as does Niles with the probable flight path.

The final left turn near Mission San Jose cannot be explained by any of the instrument procedures in force. By turning left from a southeast heading to northwest, the pilot may have planned to intercept the Oakland southeast course and proceed inbound. However, it will be recalled that neither of the two available radio range receivers was tuned to the Oakland radio range frequency. This turn, it is believed, was begun at about the time the flight was cleared by Approach Control for a straight-in approach.
